Report on Vibratory Stress Relief

CARPENTER JOB

418" L X 60,000 lbs Ingot Stripper

THE ROSE CORPORATION, a Job Shop specializing in large components, is a regular user of VSR Technology Group's stress relieving service. In this project, a 418" L, 30-ton mild steel weldment, an Ingot Stripper for CARPENTER TECHNOLOGY, was stress relieved on the shop floor in less than three hours.

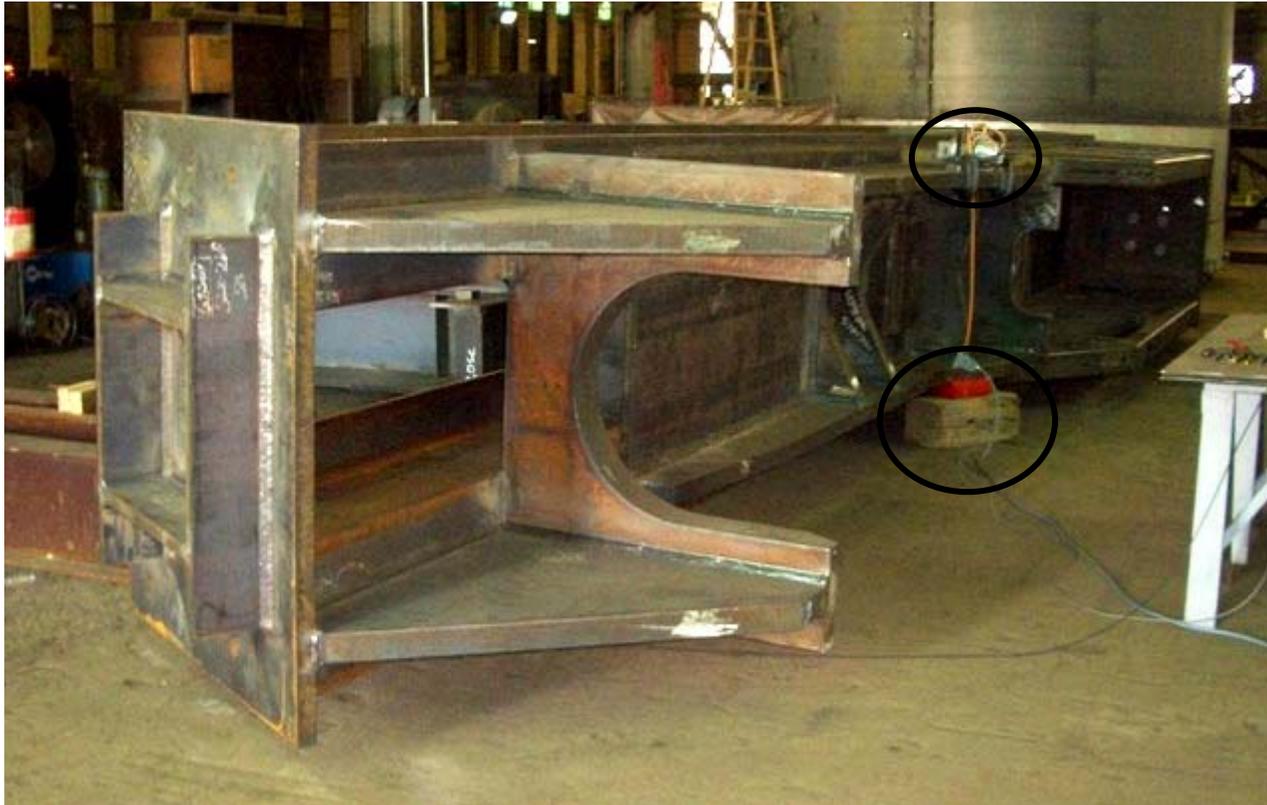
Figure 1: View from near one end of the 30-ton Ingot Stripper Frame. The Frame was isolated on 3 Isolation Load Cushions (1 is visible [circled], midway down the length of the Frame). Each Load Cushion was placed on a 10" X 10" wood block to achieve leveling and floor clearance (Frame is \approx 4" above the floor in the foreground.) The BL-8 VSR Vibrator, clamped to the Frame, can be seen directly above the Cushion (circled).

The workpiece was placed on 3 Isolation Load Cushions, which measure 10"L X 6"W X 4"H. Three is the minimum number to determine a plane, and was used to minimize damping of the Workpiece. The Load Cushions were located far from the corners or ends of the Workpiece, which also minimizes damping. Minimizing damping maximizes resonance, and flexure. Independent research has shown that flexure is required to maximize the effectiveness of vibratory stress relief. One of the Load Cushions can be seen in Figure 1; the locations of the other two are described in Figure 2.

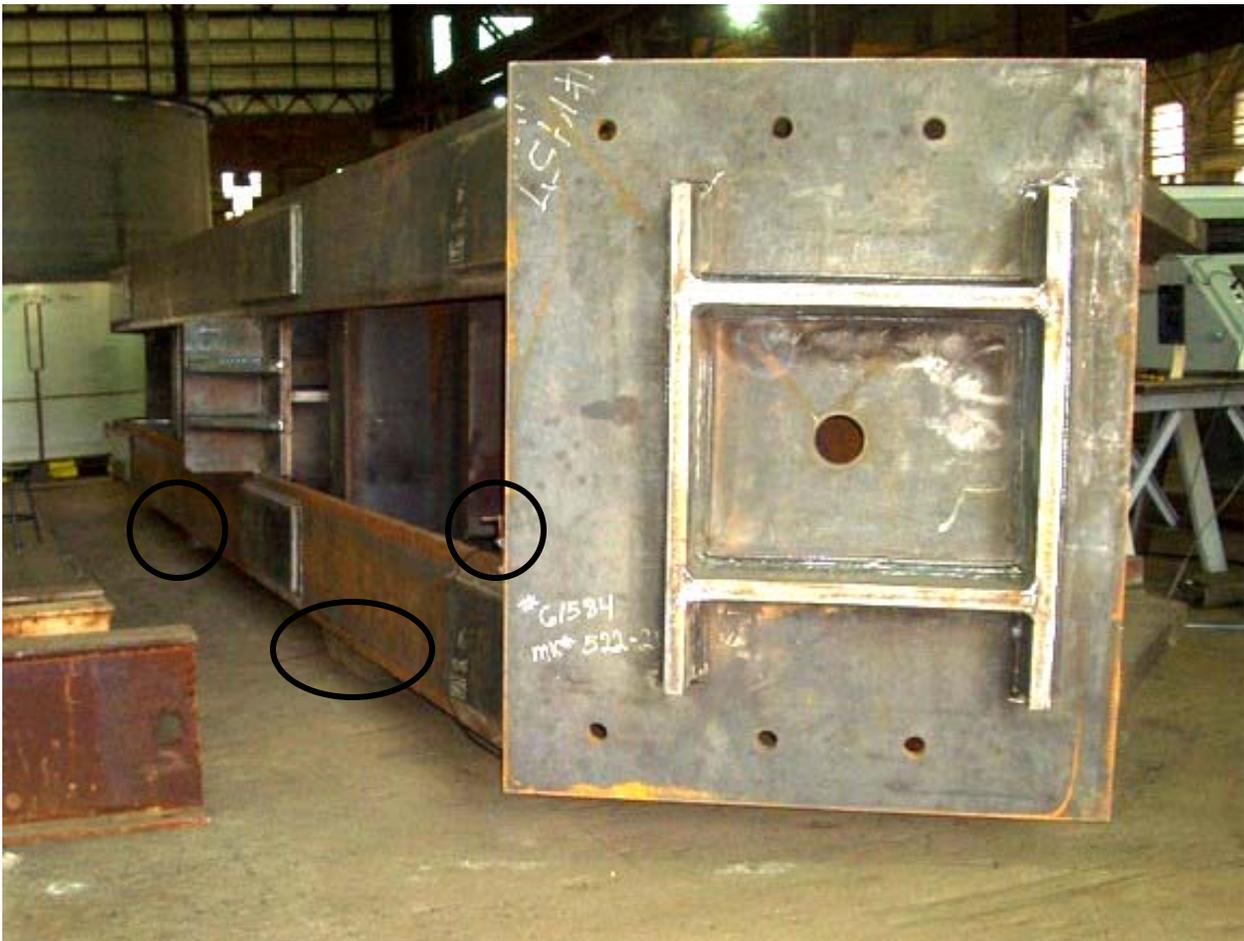
Figure 2: View showing opposite side that shown in Figure 1. Note the two wood blocks spaced at the 1/3rd points along the length. These leveling blocks hold the other 2 Cushions. This 3 point Cushion arrangement minimizes the damping of the Frame during Treatment, allowing effective resonating to take place, which produces the flexure required for the VSR Process. The Accelerometer Clamp and cable is visible on the near left corner (circled).

The Vibrator was securely clamped at the midpoint of one side, and oriented so that the Axis-of-Rotation (AOR) was aligned at an angle midway between the major axis (length) and minor axis (width) of the workpiece. The Vibrator is visible in Figure 2, and a close-up of the mounted Vibrator is shown in Figure 4.

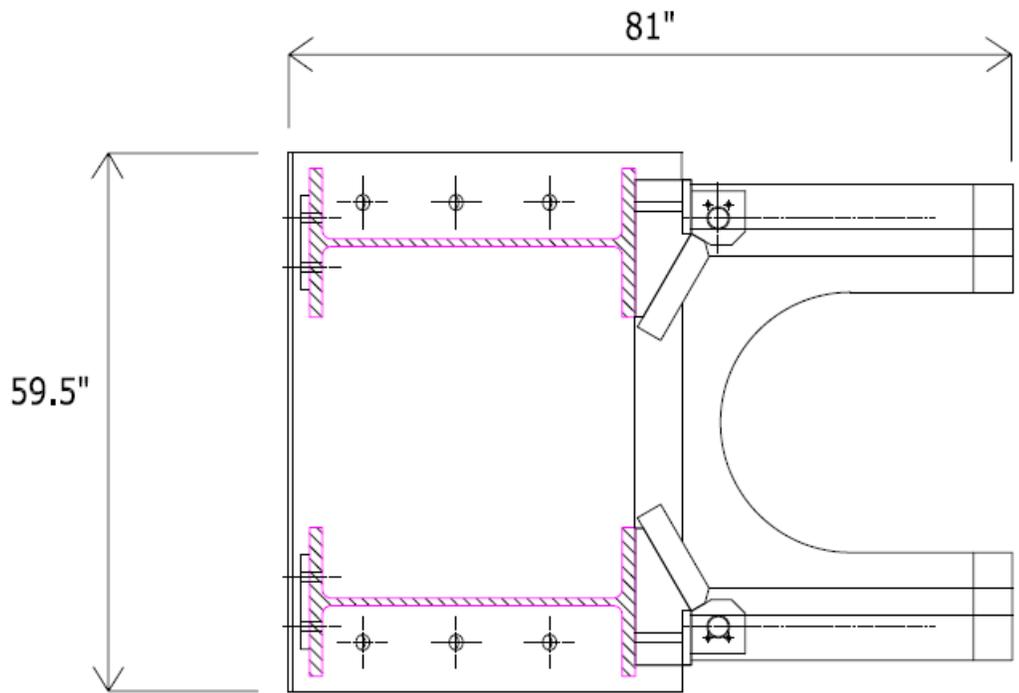
Figure 3a: Cross-sectional view of Ingot Stripper Frame. This portion is seen in Figure 1.

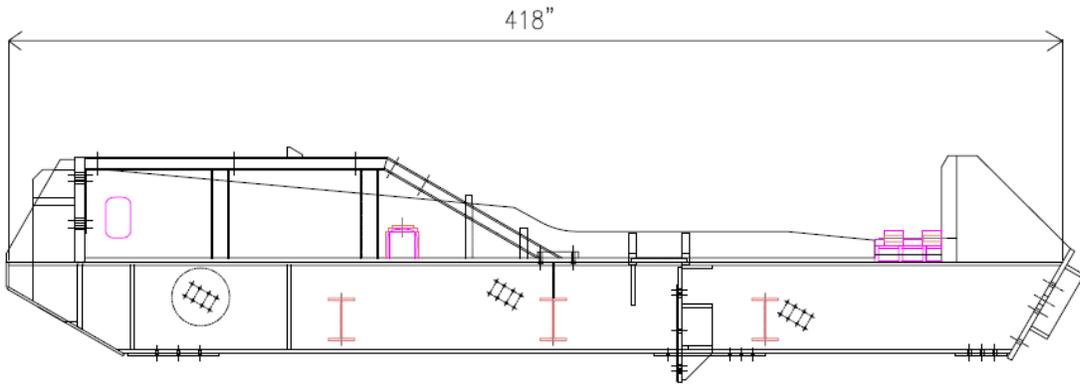
Figure 3b: Overall plan view of Frame, as oriented during Treatment. Right portion of this view is in the foreground of Figures 1 and 2, as is the cross-sectional view (3a). Note flange on bottom, which is visible on the left in Figure 2.

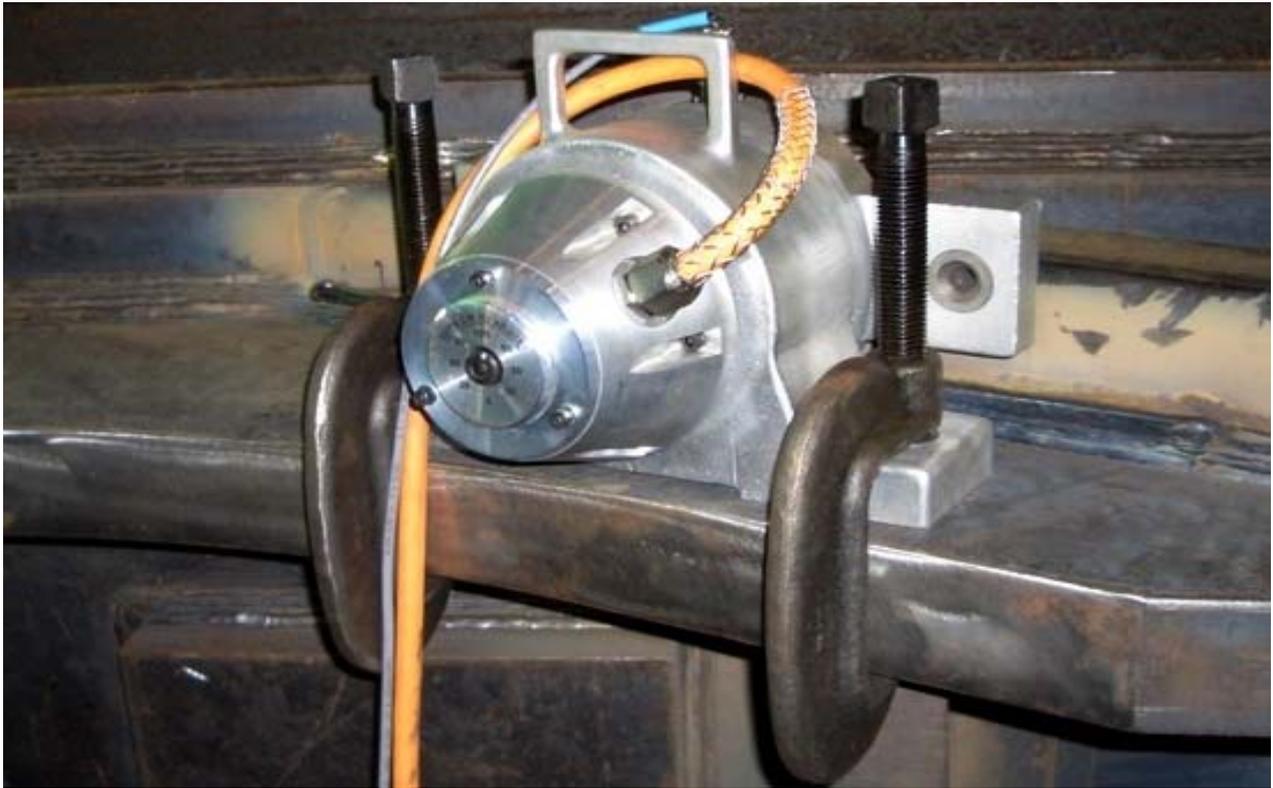
Figure 4: Close-up of System's BL8 Vibrator. This Vibrator has adjustable speed (10 – 8,000 RPM) and adjustable unbalance (0.2 – 4.0 in-lbs.), the unbalance scale is visible on the back of the vibrator. It also features two sets of mounting feet, so that it can be oriented most effectively. Hardened steel inserts (Rc 50) in the mounting feet allow strong, effective clamping, without crushing the aluminum-magnesium alloy housing. Vibrator is driven by a 3 HP (≈ 2.3 kW) brushless DC motor.

The Vibrator's unbalance was initially adjusted to 40% of the available 4.0 in-lbs of unbalance, ie, 1.6 in-lbs. After running the System's Quick Scan for calibration purposes, the unbalance was increased to 80%.

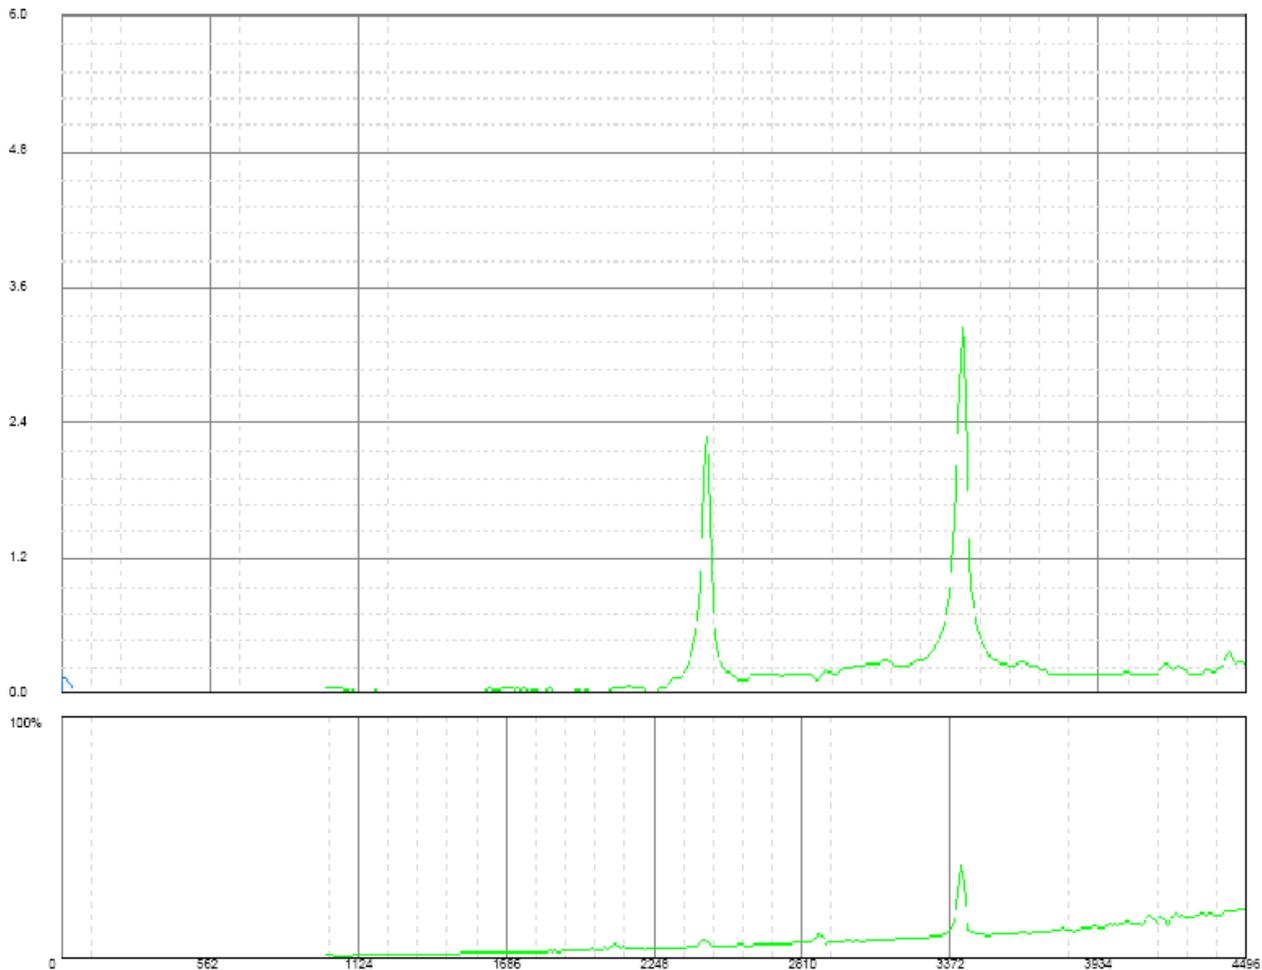
Figure 5: First Pre-Treatment Scan. VSR Treatment Chart Data consists of two plots, an upper plot showing workpiece acceleration (or Acceleration Curve), and a lower plot showing Vibrator Input Power (or Power Curve). Both data sets are plotted on a vertical axis vs a common horizontal axis of Vibrator RPM. Scanning is done automatically by the VSR-8000 System, and was done at a rate of 10 RPM / sec. – a speed which will produce high-resolution charts, accurately depicting the resonance pattern.

Peaks in the upper curve are resonance peaks of the workpiece. If a peak occurs in the power curve, it indicates that a load upon the Vibrator has also occurred. In the Chart above, the full-scale of the acceleration (adjustable from 1g thru 50g) was set at 6g. Full-scale for the power is preset permanently at the power capacity of the BL8 Vibrator's motor: 100% = 2.3 kW. Full-scale of the RPM (adjustable to 8000-RPM) was 4500-RPM. Scale adjustments can be made after a scan has been performed, even displaying data (such as a tall peak) that was originally off-scale, one of many "user-friendly" aspects of the VSR-8000 System. Pre-Treatment Scans are recorded in **green** since the Workpiece is "**green**" (freshly welded or cast).

After this initial setup, a Pre-Treatment Scan was run, which uncovered two large resonance peaks. This Pre-Treatment Scan is shown below as Figure 5.

Treatment is done by tuning on and dwelling upon the peaks identified in the Pre-Treatment Scan. The VSR-8000 System has very tight speed regulation ($\pm 0.02\%$). The Vibrator can be tuned in increments of 1-RPM. This enables the Vibrator to be tuned directly on the resonance peaks, so that maximum flexure, and stress relief take place.

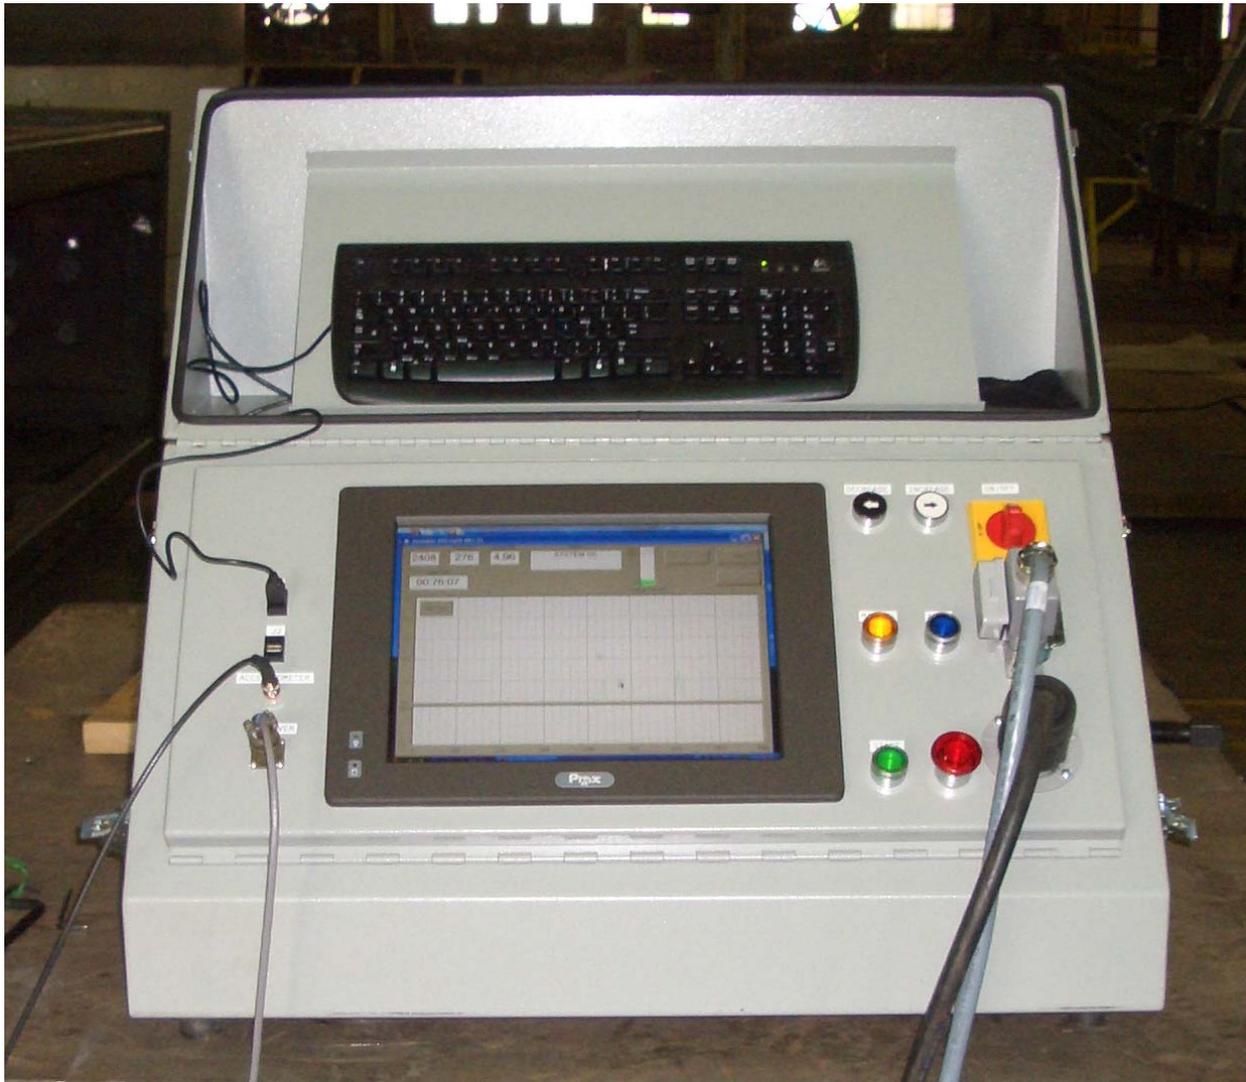
Figure 6: MX-8000 VSR Console. Touch-screen computer displays VSR Scan Data, digital data (RPM, power, and acceleration). Scan data is saved in Adobe/pdf format. Low voltage connections are on left (2 USB Ports, Accelerometer, and Vibrator resolver / tachometer), and higher voltage connections on right (power in, motor).

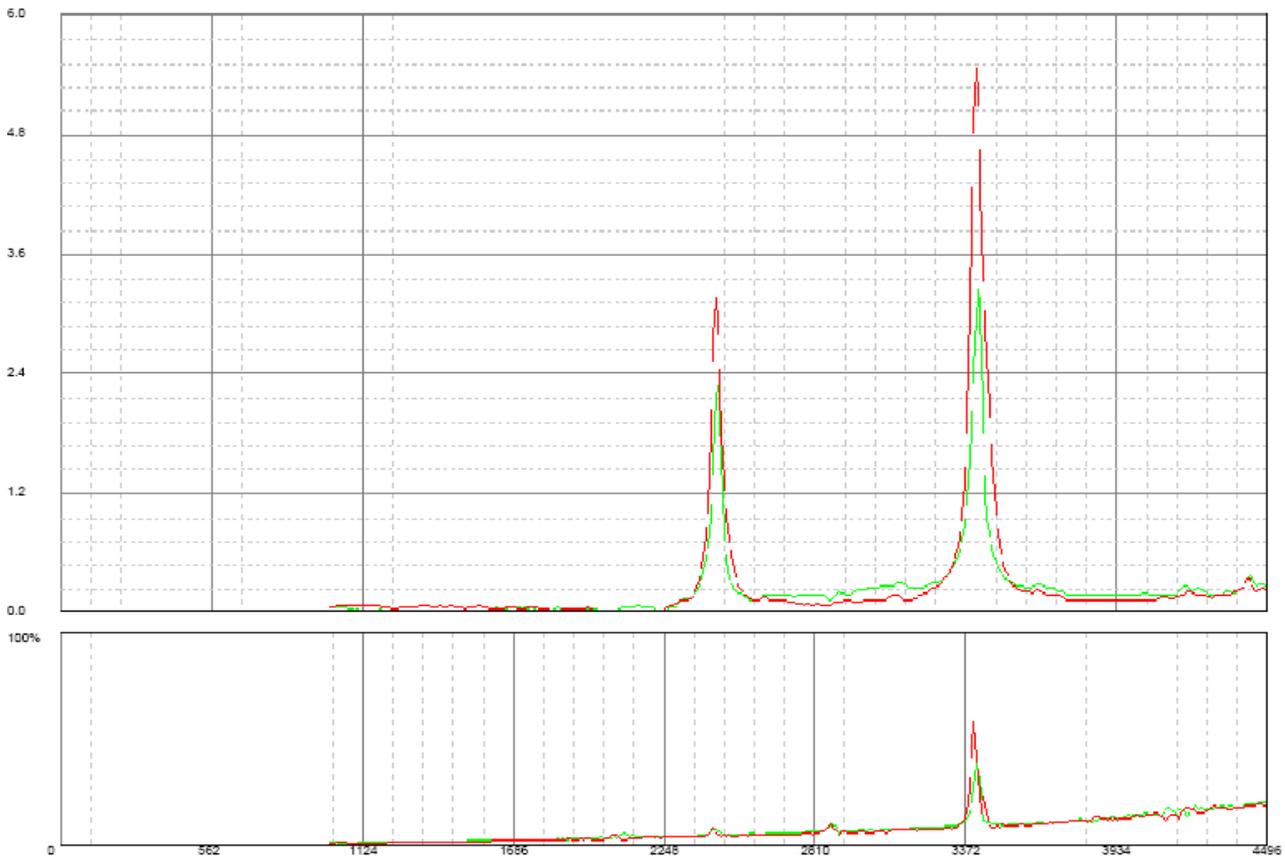
Figure 7: First VSR Treatment Chart. After the operator determined that peak growth (major response), and peak shifting (minor response) had been completed, a Post-Treatment Scan in **red** was automatically recorded, and superimposed upon the **green** Pre-Treatment Scan. Peak growth for the smaller peak, located at 2370-RPM, was $\approx 35\%$, and for the larger peak, located at 3394-RPM, peak growth was $\approx 66\%$.

After tuning on the 2370-RPM peak, peak growth occurred within two minutes, rising from 2.4g to 3.0g. The remaining increase, amounting to growth of 35%, took an additional 25 minutes to achieve. The peak at 3394-RPM was then tuned on. An increase had already taken place, due to the earlier Treatment of the first peak, this peak started out at 4.1g. The peak continued to grow, maxing out at a level 66% higher. These changes were then documented by performing a Post-Treatment Scan, shown in Figure 7.

As evidenced by the classic response to the VSR Process seen during the 1st Treatment, and the highly stable resonance pattern seen during the 2nd Treatment, this workpiece will remain dimensionally stable throughout machining, assembly, transport, and field usage.

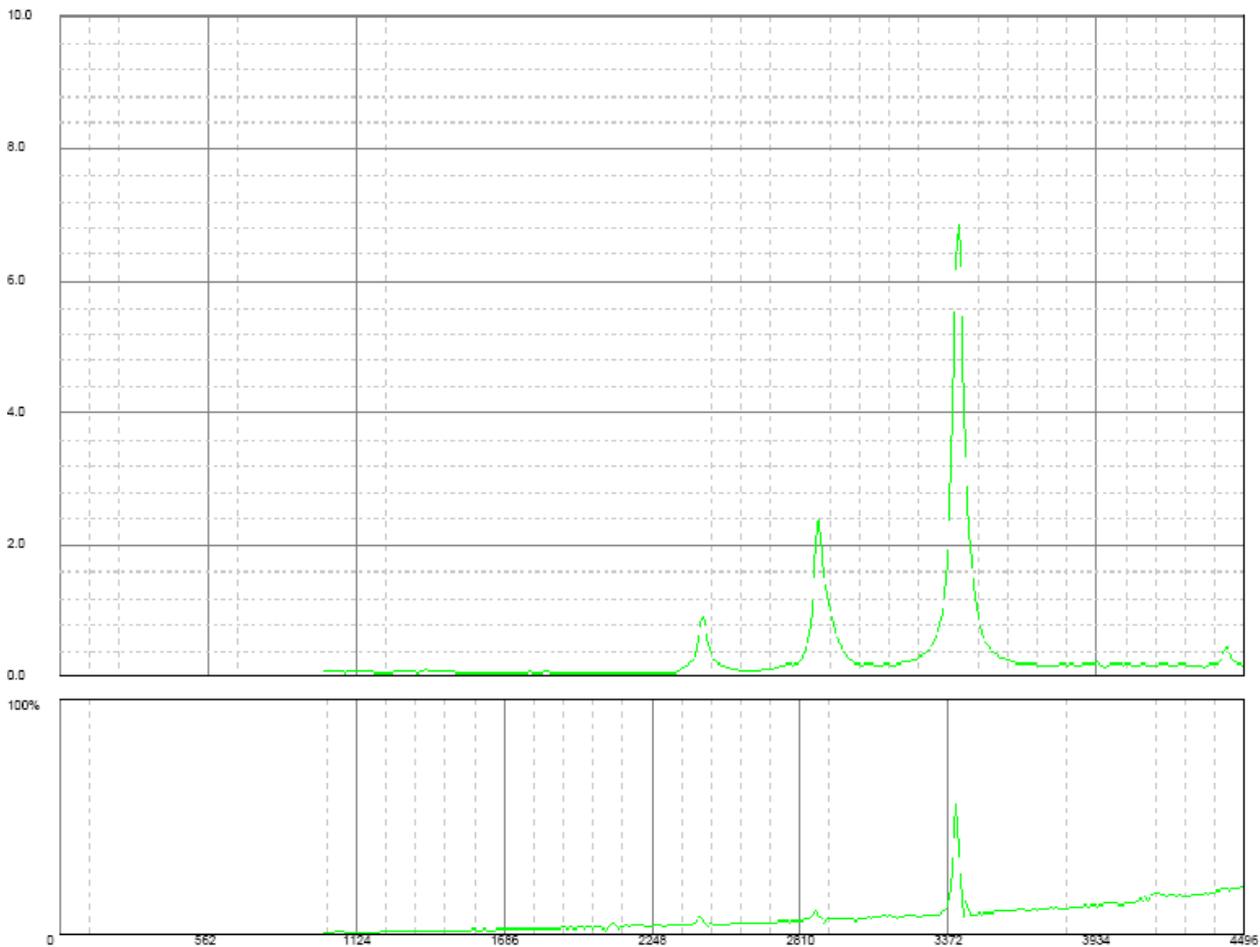
Figure 8: Second Pre-Treatment Scan with horizontally oriented Accelerometer. This was recorded with the Accelerometer reoriented so as to be most sensitive to horizontal deflection. By reorienting the vibration sensor, an additional "hidden" peak at 2843-RPM was revealed. However, tuning upon this new peak, caused very little additional peak growth or shifting, see Figure 9.

During the scanning, there was an audible hum emanating from the workpiece. Normally associated with a resonance peak, this hum occurred at a vibrator speed between the two peaks, but no peak was visible. This peak was uncovered by reorienting the Accelerometer, so as to be sensitive to horizontal amplitude. A new Pre-Treatment Scan was run, which uncovered the "hidden" peak, allowing a Treatment of this peak, *see* Figure 8.

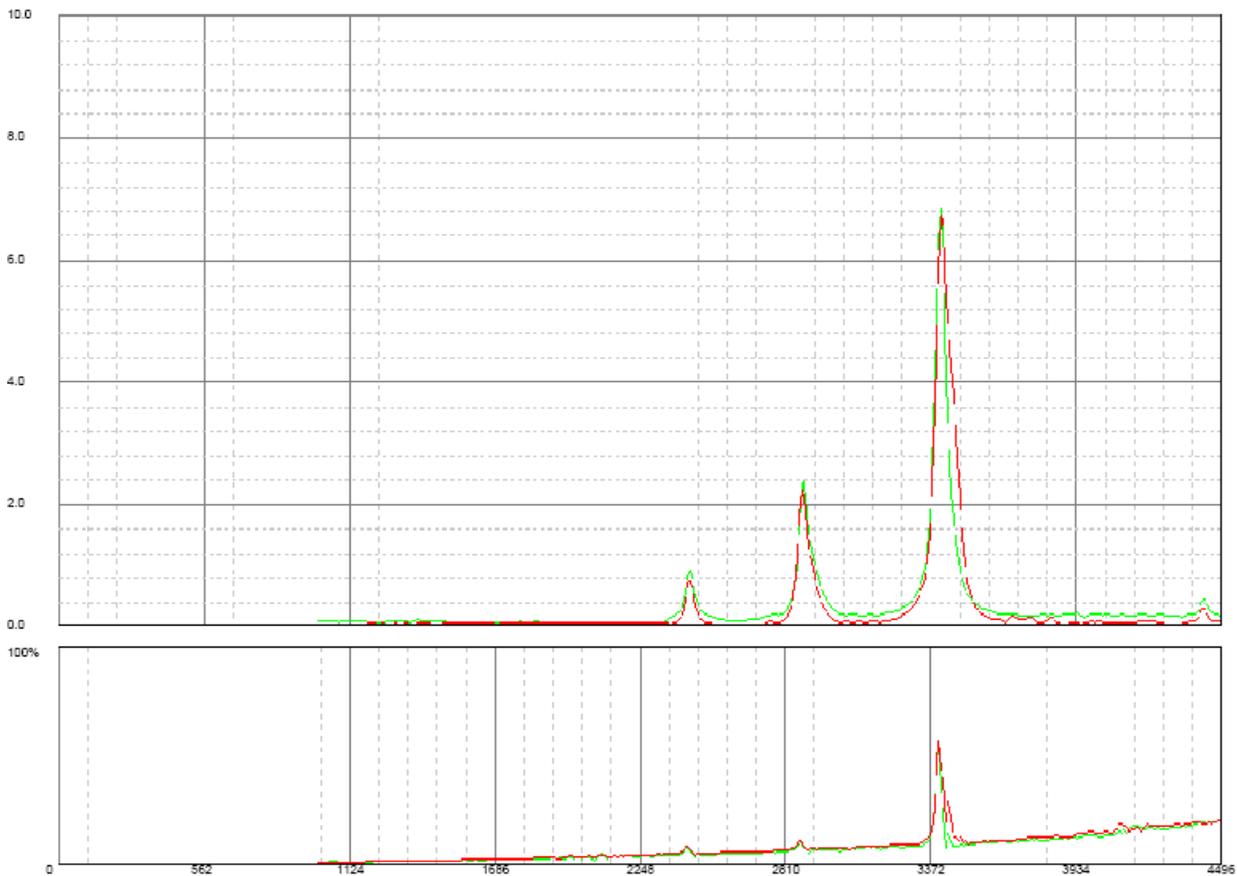
Figure 9: Second VSR Treatment Chart shows little additional growth. There is less than a 0.12g variation between the Pre-Treatment and Post-Treatment Scans, amounting to a 2 – 4% difference between the Pre- and Post-Treatment Scans.
