## **Report on Vibratory Stress Relief**

### **THREE D METAL**

### **Clamshell Buckets Job**

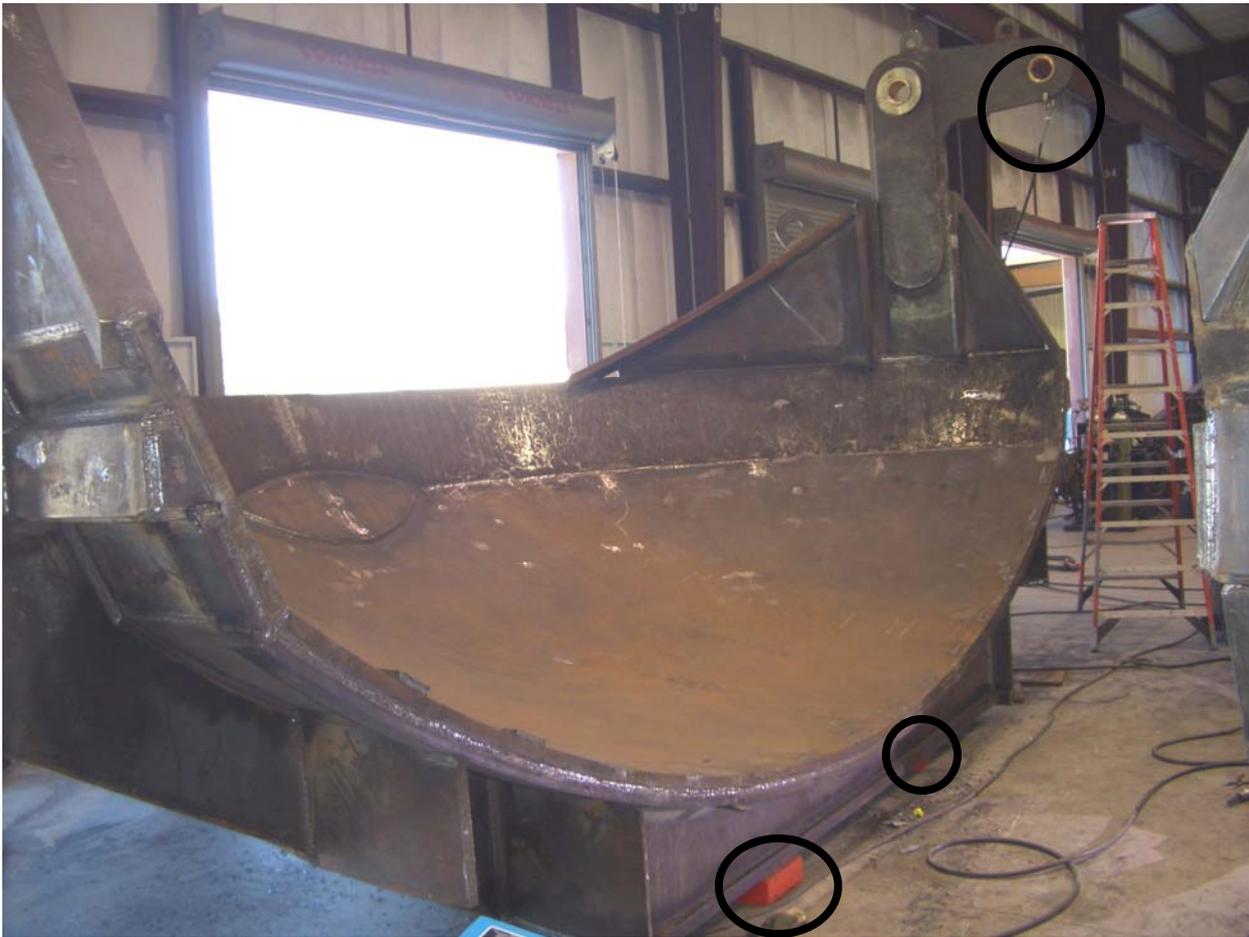
**Figure 1:** 24.5 ton Clamshell Bucket half setup for VSR Treatment. Note location of two Load Cushions (circled); the other two Cushions were placed on the opposite side (one being visible in Figure 2). The Accelerometer is visible on right lifting arm (circled), near the top of the photo. This particular Accelerometer location was used during a second Treatment of this workpiece, which turned out to be unnecessary (first VSR Treatment was fully effective), as indicated by the VSR Treatment Charts shown in Figures 3 – 6.

The first workpiece was placed on four Isolation Load Cushions. These Cushions were placed in such a manner as to minimize damping of the workpiece, which maximizes resonant response, *see* Figures 1 and 2. Resonant frequency vibration is used because of its ability to maximize the flexure of the workpiece, which is key to the effectiveness of vibratory stress relief. Several independent research works, including those of Hahn<sup>1</sup>, Shankar<sup>2</sup>, and Yang, Jung and Yancey<sup>3</sup>, have proven that resonance frequency vibration is the most effective form of vibration to relieve stress.

The Accelerometer was initially placed in the location shown in Figure 2. Later, after the first VSR Treatment, the Accelerometer was moved to the location shown in Figure 1. Although this Accelerometer location did pick-up some additional resonance peaks, shown in Figures 5 and 6, Vibration dwell on these peaks did not cause them to grow or shift which proved it did not stress relieve the workpiece any more than the peaks displayed in Figure 3 and 4.

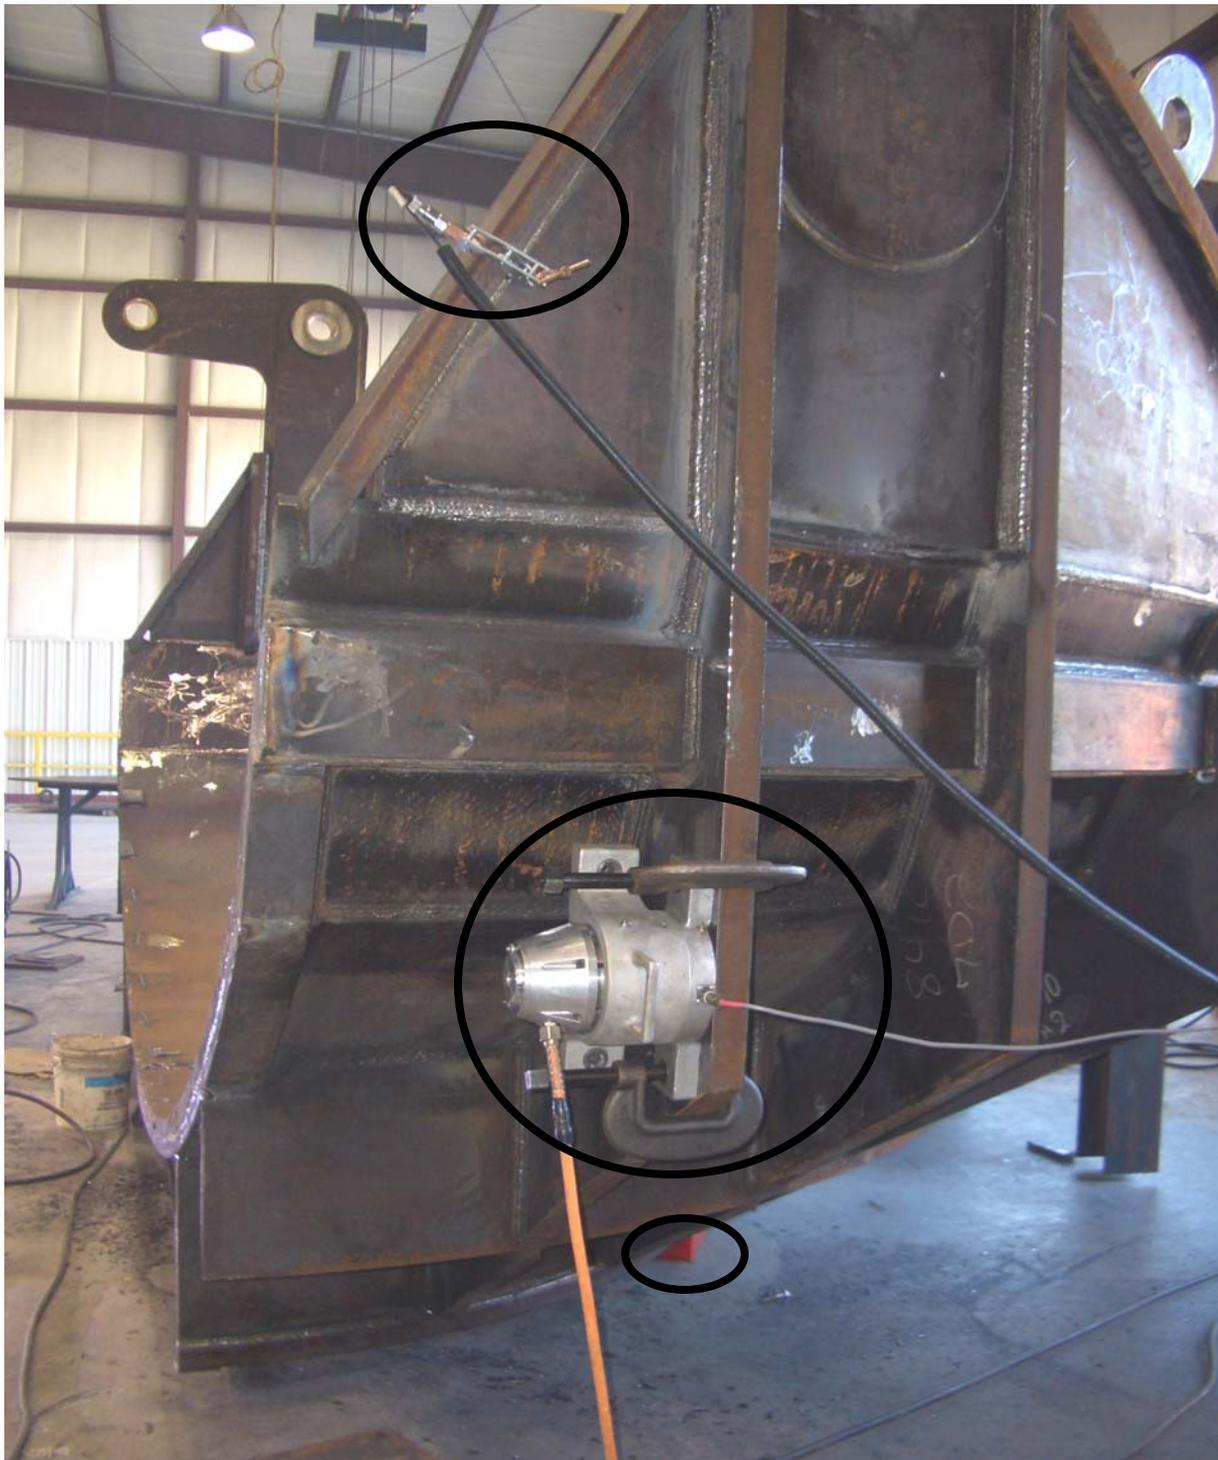
**Figure 2:** Another view of Clamshell setup for VSR Treatment. One of two Load Cushions supporting the rear of the Clamshell is visible (circled), below the Vibrator (circled). Note that the support leg on the right is purposely not touching the floor; the full weight of the workpiece rested on the 4 Load Cushions.

The Vibrator was clamped to a vertical plate on the side of the workpiece, *see* Figure 2.

The Vibrator oriented with its Axis of Rotation Horizontal (AOR-H), as shown in Figure 2, was found to produce the best resonances.

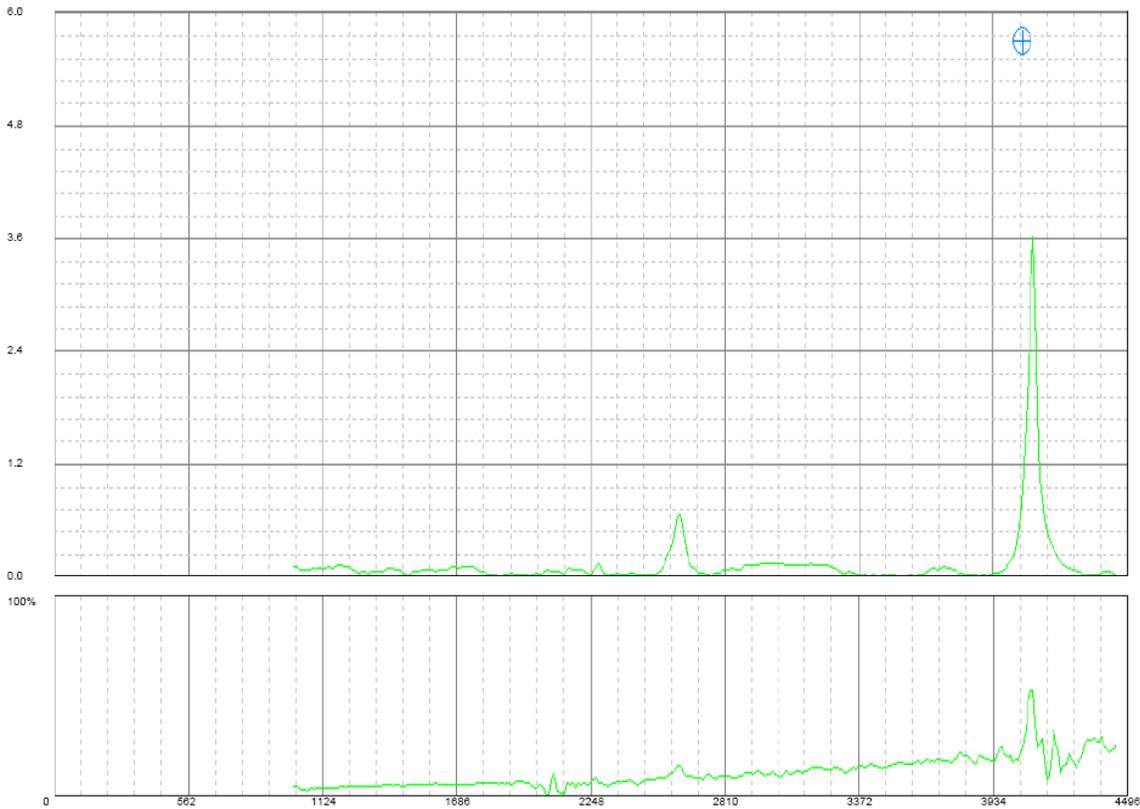
**Figure 3: First Pre-Treatment Scan.** VSR Treatment Charts consist of two plots: An upper plot of workpiece acceleration and a lower plot of vibrator input power, both of these plotted on a vertical axis vs. a common horizontal axis of vibrator RPM. Peaks in the upper plot are resonances of the workpiece. Peaks in the lower plot are resonances that cause increased, perhaps excessive, vibrator input power (excessive power is easily rectified by lowering the Vibrator unbalance setting, repositioning the Vibrator, or a combination of both).

Full-scale for acceleration is adjustable from 1g – 50g, and can be adjusted after a scan is made, in the event the plot is too "short" or "tall". Max setting for this Chart was 6g.

Full-scale for vibrator power is preset / fixed, with 100% = 3 HP (  $\approx$  2.2 kW ), the power capacity of the brushless DC motor that powers the BL8 Vibrator.

Full scale for Vibrator RPM is adjustable up to 8000-RPM, the maximum speed of the BL8 Vibrator. For this Chart, 4500-RPM (defaulting to 4496) was the max RPM used.

Pre-Treatment Scan data is plotted in **green**, since the workpiece is "green" (not stress-relieved, like a green casting).

The real-time cursor (**blue** circled) is visible above the large peak.
